# J/70 Crew Positioning

## RRS 49 CREW POSITION; LIFELINES

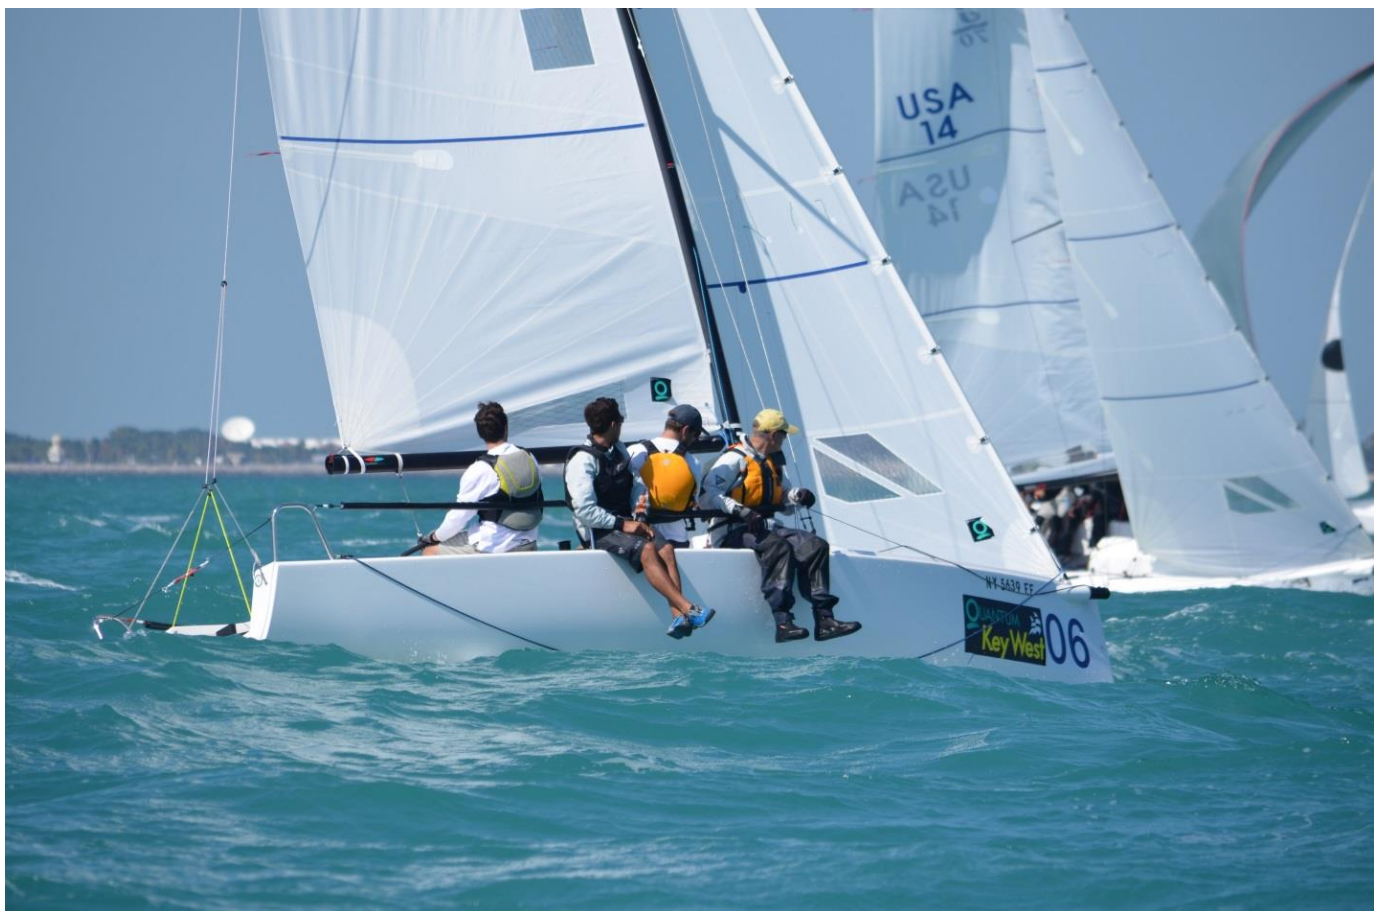
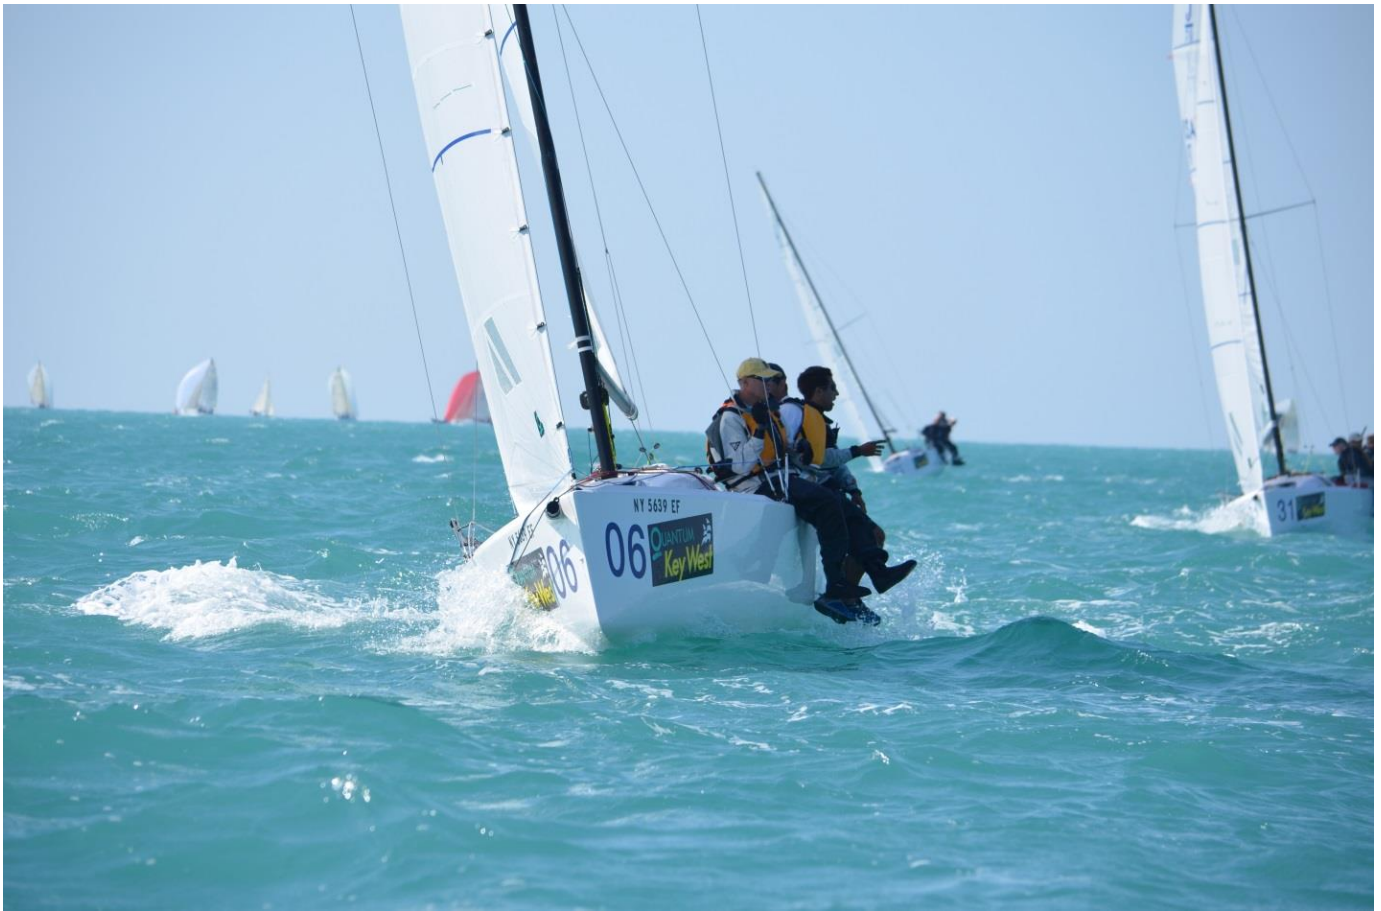
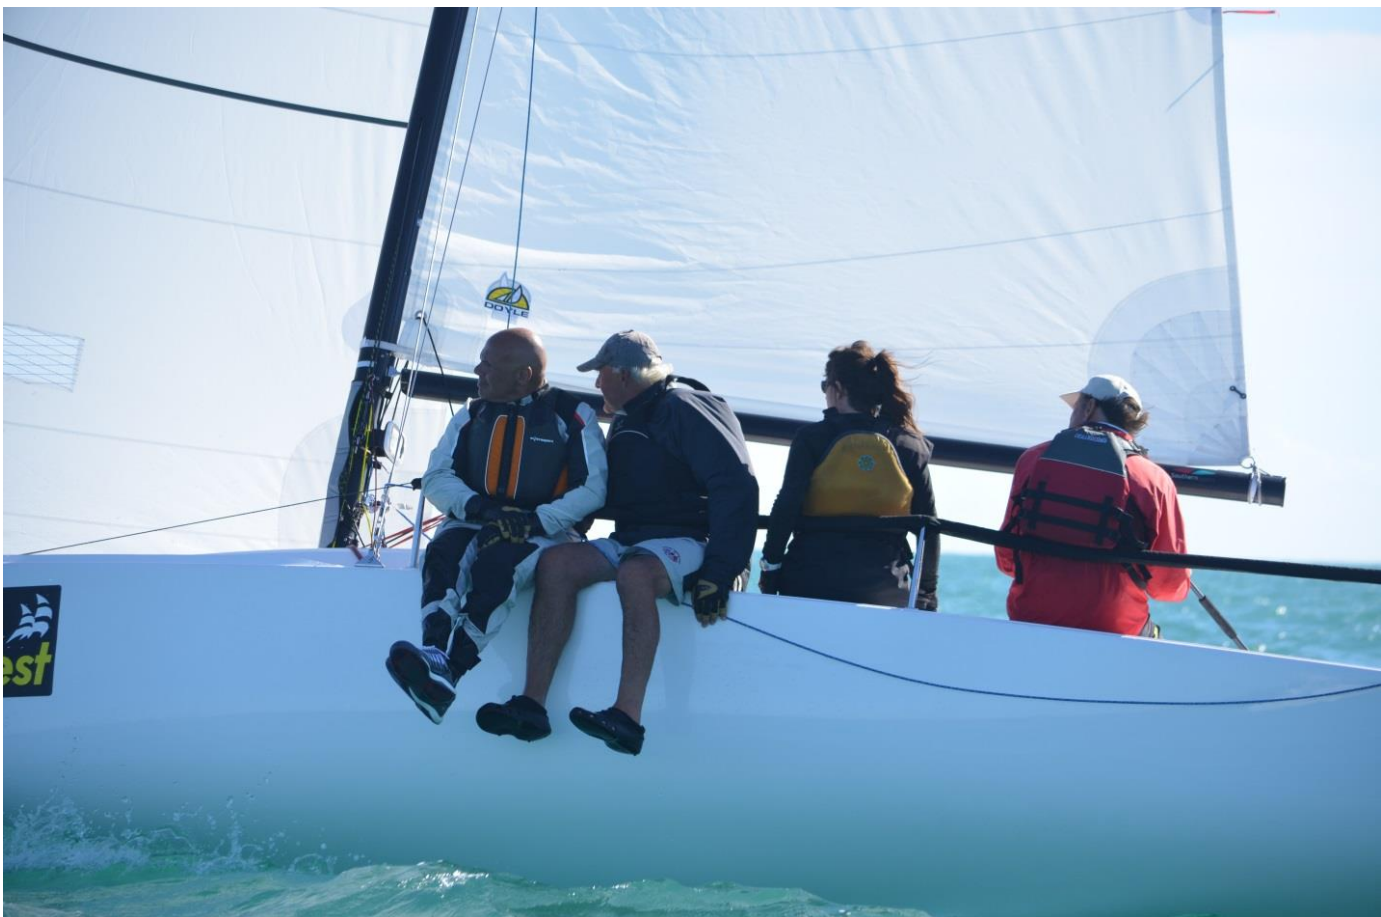
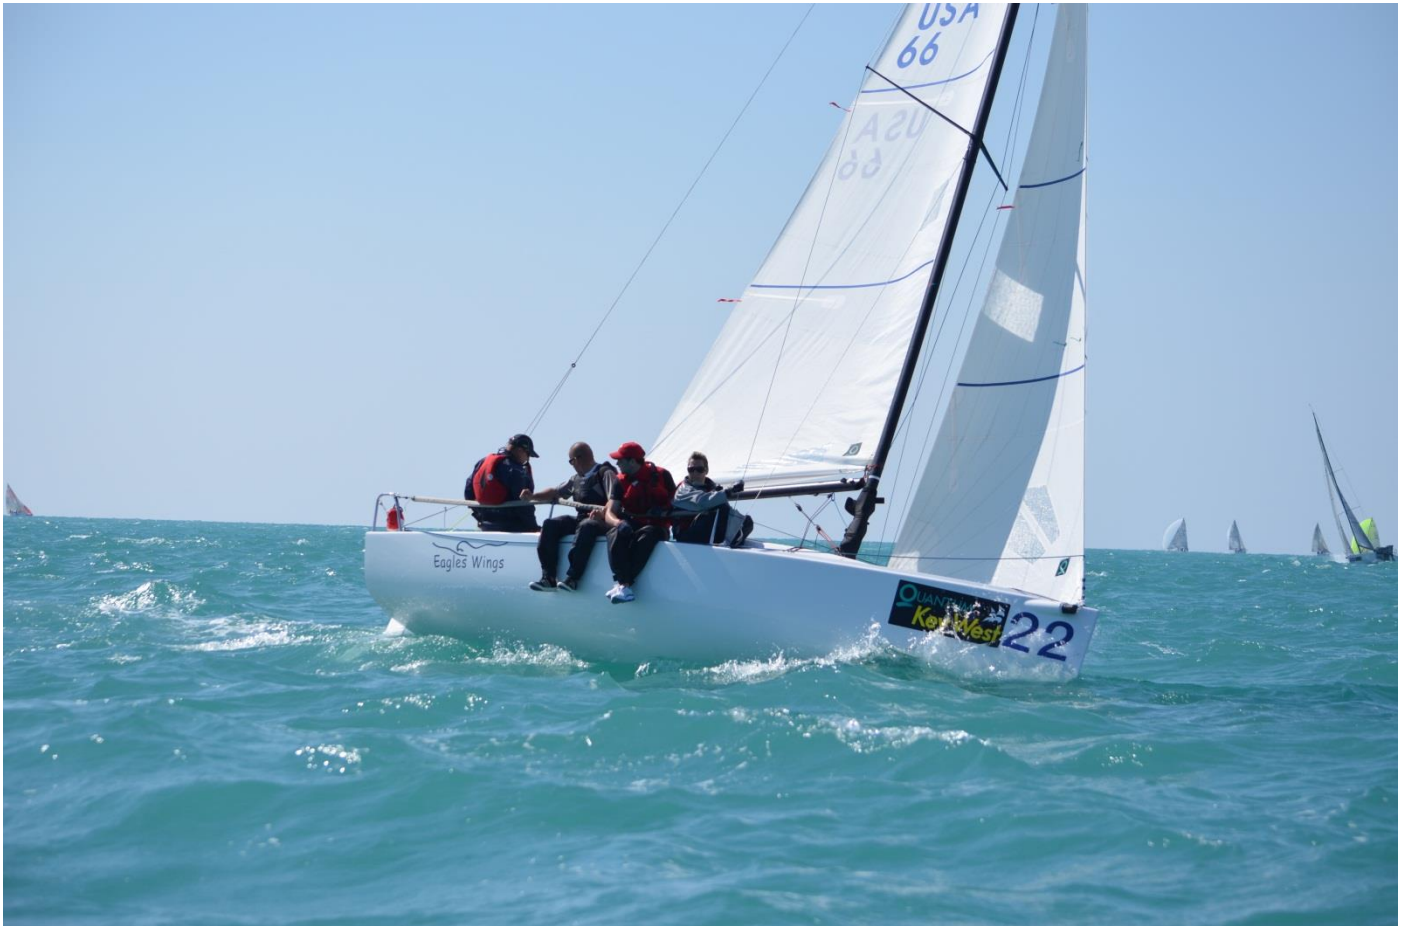
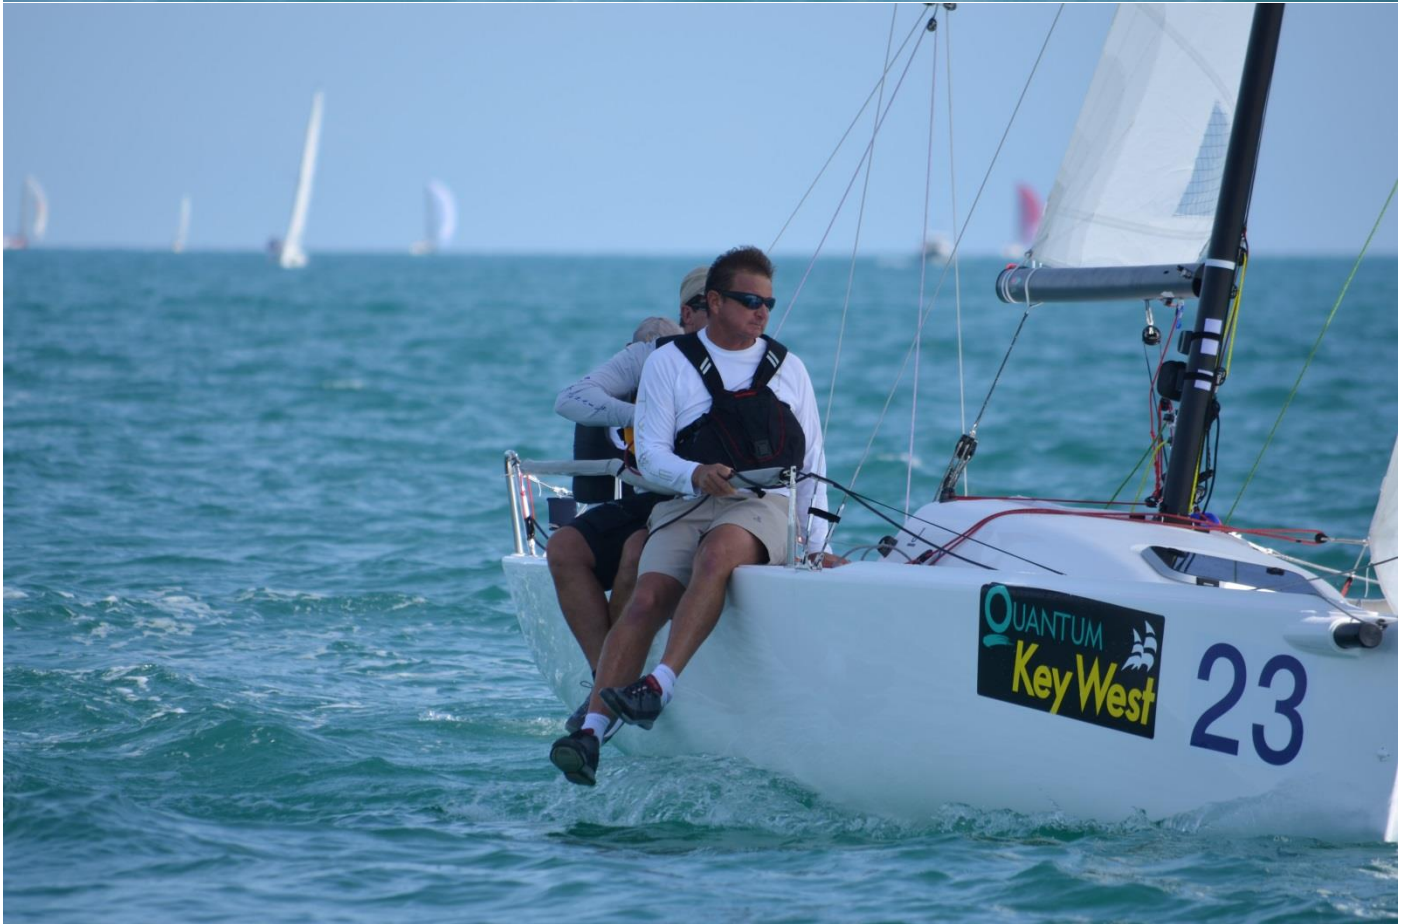
The next 5 photos are examples of proper crew positioning

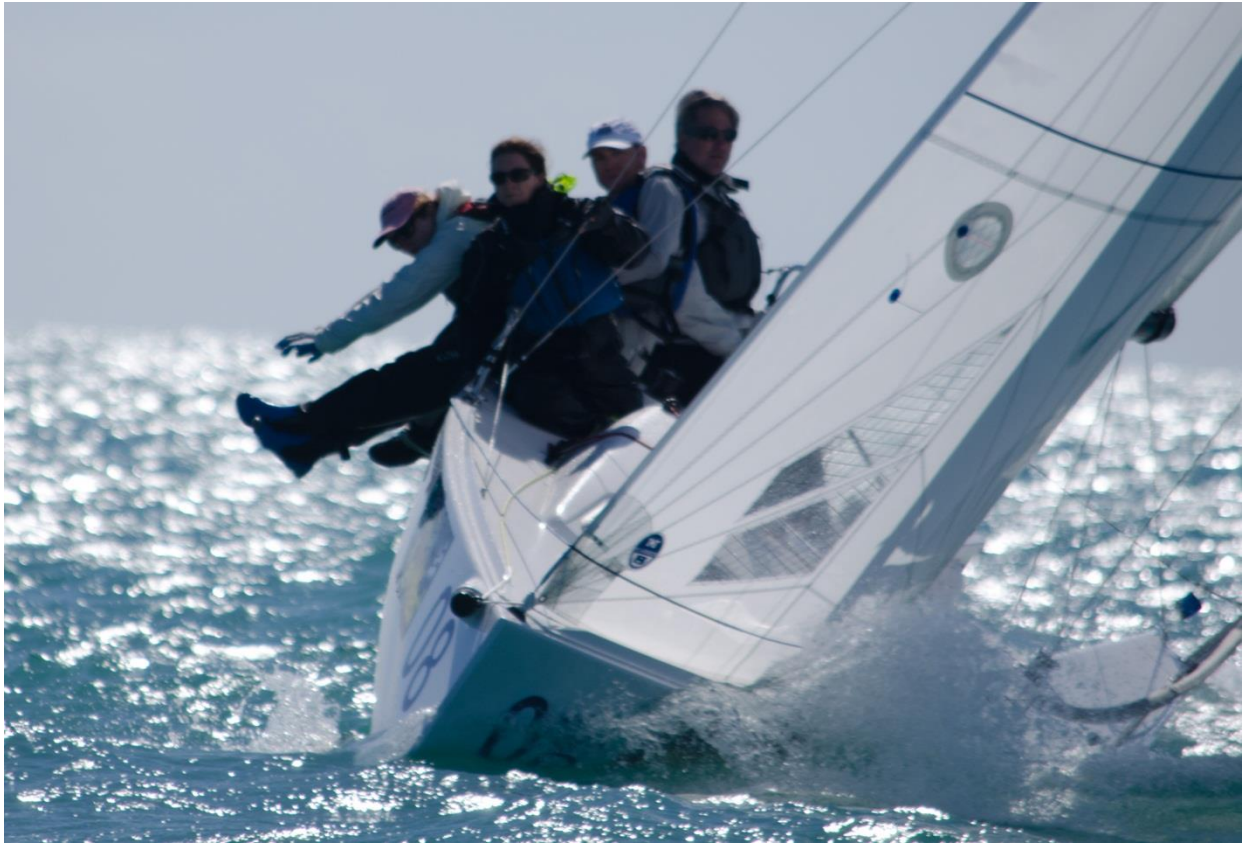
Notice the crew in white jacket and red hat
